Philips LCD TV 42PFL5604H 107 cm (42") Full HD 1080p digital TV with Pixel Plus HD
42PFL5604H/12
Q543.3ELA

Service information

Reference no.: GSC_72752

Service SSB does not contain main TV software.

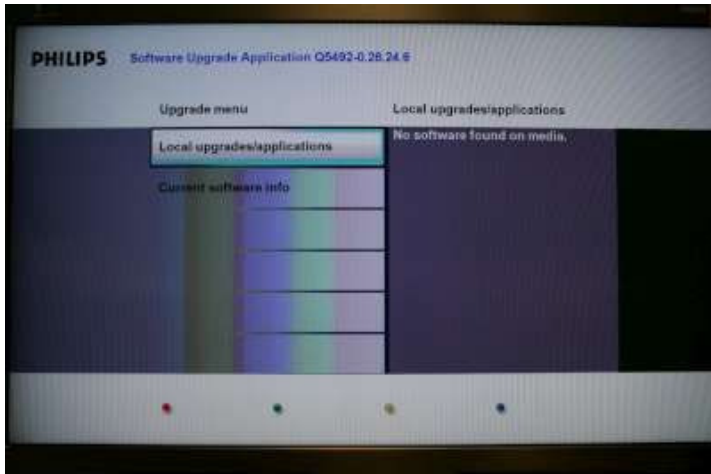
Fig. 1. Download application

- 1) Mount the Service SSB into the TV set. After start-up, normally the download application will appear on the screen (see figure 1).
- 2) Download the latest main software (FUS) from the www.p4c.philips.com website.
- 3) Create a folder "upgrades" in the root of a USB stick (size > 50 MB) and save the "autorun.upg" file in this "upgrades" folder. Note: It is possible to rename this file, e.g. "Q549_SW_version.upg", this in case there are more than one "autorun.upg" files on your USB stick.
- 4) Plug the prepared USB stick into the TV set, and select the "autorun" file in the displayed browser on the screen (see figure 2).
- 5) Now the main TV software will be loaded automatically, supported by a progress bar.
- 6) Set the correct "display code" via "062598-HOME-xxx", where "xxx" is the 3-digit display panel code (see sticker on the side/bottom of the cabinet).

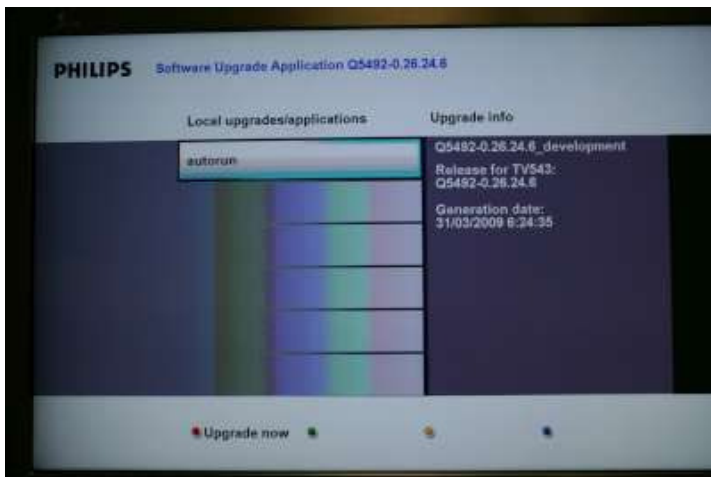
Fig. 2. Select autorun file

- 3) Plug the prepared USB stick into the TV set, press cursor "Right" to enter the list, and navigate to the "autorun" file in the UART logging printout via the cursor keys on the remote control. When the correct file is selected, press "OK" (see figure 4).
